## Case: Underwater inspection of trade-yards

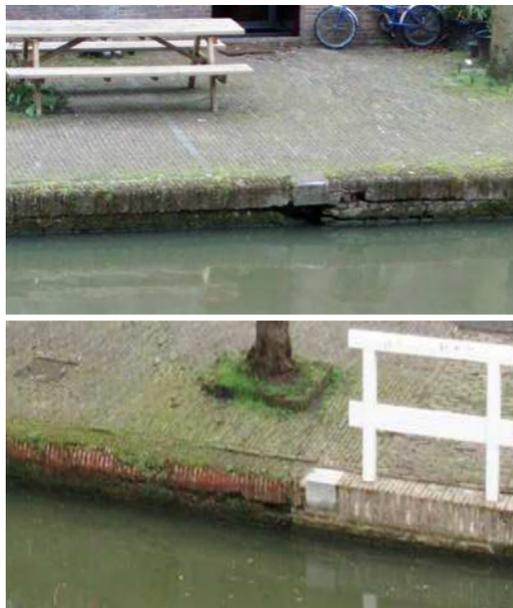
**Severe damage in walls and bricks at the Utrechts trade-yards**

decline, coming from below the waterline. One can see long cracks in the brickwork. Some of those cracks are a few metres long. Masonry is severely damaged and bricks disappear from the walls. And this is just what you can see.

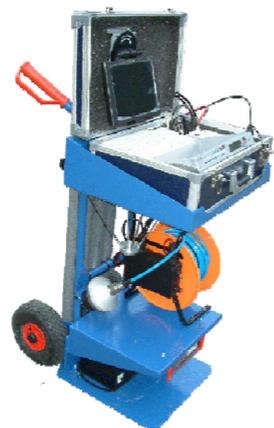
**Monitor on trolley**

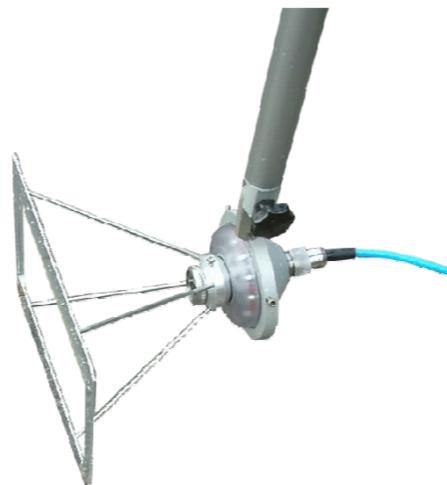
**Camera with measuring window on a stick**

Along the walls of the Utrecht trade-yards severe damage is visible in walls and bricks. Underwater the situation is even worse. To inspect divers go into the water. They examine the situation, taking photographs and measuring the damage. A new cheap solution is found in using a camera on a stick. This stick is dipped into the water with its measuring equipment. Now they inspect from dry soil.

The Utrecht local authorities have allocated money for maintenance and renovation. Special divers go into the water to examine the situation. They inspect the walls, taking photographs and measuring the damage. This way of inspection is quite expensive. Camtronics came up with an idea to reduce costs and a simplified mode of working. A watertight camera with extra lighting was assembled on a stick. A special measuring window was designed to reproduce proportions of filming. On a trolley a monitor and recorder was mounted. Local officials now dip the stick into the water filming cracks and missing bricks. No divers are necessary now and all inspections are done from dry soil.
